Products: VC520 Pro2 / Expansion Speakerphone

VC520 Pro2 Firmware Version: 0.0.7204.22

VC520 Pro expansion speakerphone: v0.0.8002.14

Published Date: Oct. 03, 2023

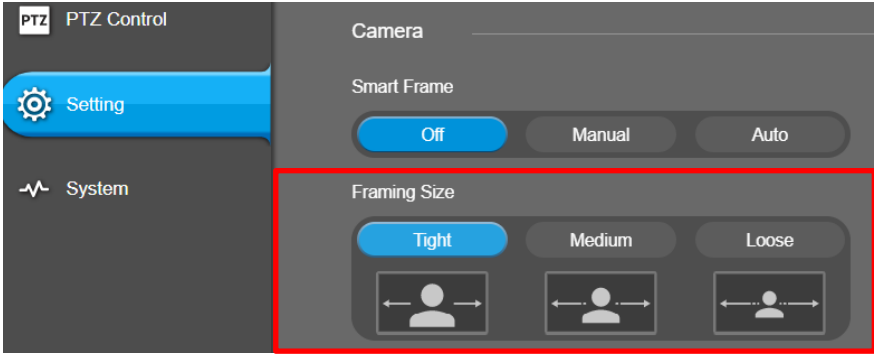
0.0.7200.80	<ol style="list-style-type: none"> Change framing size description: change “Loose” to “Wide” Image default setting change
0.0.7200.78	<ol style="list-style-type: none"> Add “framing size” function. When auto framing, the zoom in size has different options so that the new comers can be detected for different using scenario. Please upgrade PTZApp2 to the latest version to have this function.

<p>Tight (default): It provides a close-up view of meeting participants.</p> <p>Medium: It provides Establishes a medium view of meeting participants.</p> <p>Loose: It provides a wide view of meeting participants.</p> <ol style="list-style-type: none"> Change people count behavior. When streaming is off, people counting function keeps running so that 3rd party app still can get the data. When under auto frame mode, whenever the USB streaming is on, camera will trigger framing detection for once no matter there is people or not. Enhance Auto focus speed, especially when people are in front of whiteboard/ TV screen. Enhance WDR performance.
0.0.7200.64	<ol style="list-style-type: none"> Improve sensitivity of Preset framing function and image clarity.
